November 6, 2023
File: 23016

**Re: Slope Stability Assessment Letter Report
Proposed Residential Development, 4933 Victoria Avenue North, Vineland, Ontario**

- Enclosure 1: Landtek Limited Borehole Logs
- Enclosure 2: Slope Stability Rating Chart
- Enclosure 3: Site Photographs 1 to 3
- Enclosure 4: Drawing 23016-01: "Site Features Plan and Section"

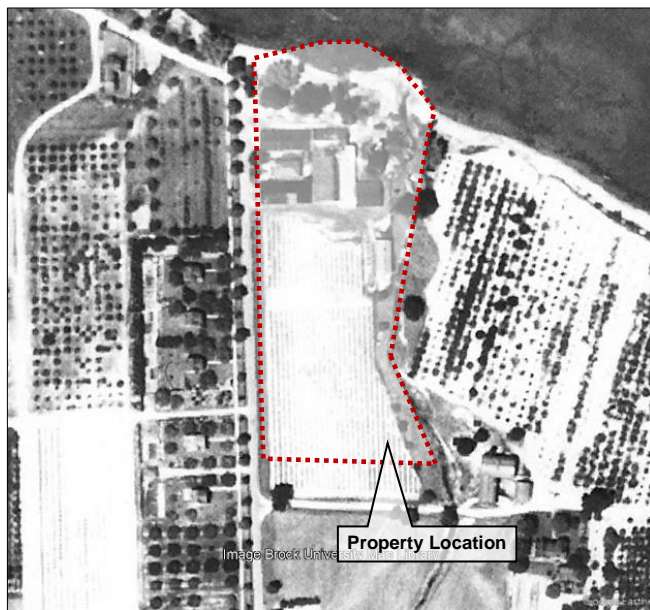
Figure 2: 1934 aerial photograph extract.

Prior to development in its current layout, the property appears to have been of agricultural use, with aerial photography from 1934 (see Figure 2) showing the site to be within an area of maintained farmland.

Prudhomme Creek is also noted to be in its current alignment and that vegetation across the eastern area of the property boundary and creek slope comprises dense vegetation and a notable tree canopy.

Except for the construction of coastline defense systems, the alignment of the Prudhomme Creek outfall and Lake Ontario shoreline shows no significant deviation since at least 1934, as shown in the aerial photograph extract presented as Figure 2.

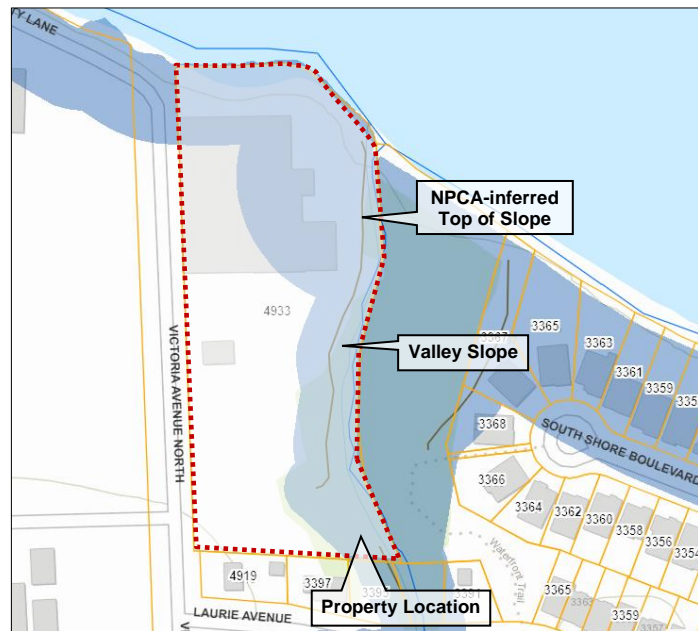
Figure 3: NPCA Watershed Explorer extract.

The nearest surface water feature is Prudhomme Creek that bounds the property to the east, as seen on Figure 3. Water flow rates are reported by the NPCA to be low to moderate. Prudhomme Creek outfalls into Lake Ontario that bounds the property to the north.

Based on the findings of the site reconnaissance, it is considered by Landtek that the Top of Slope identified by the NPCA on their Watershed Explorer, as shown in Figure 3, is in general conformance with the available contour information and observations made during the site reconnaissance, as presented on Drawing 23016-01 "*Site Features Plan and Section*", attached as Enclosure 4.

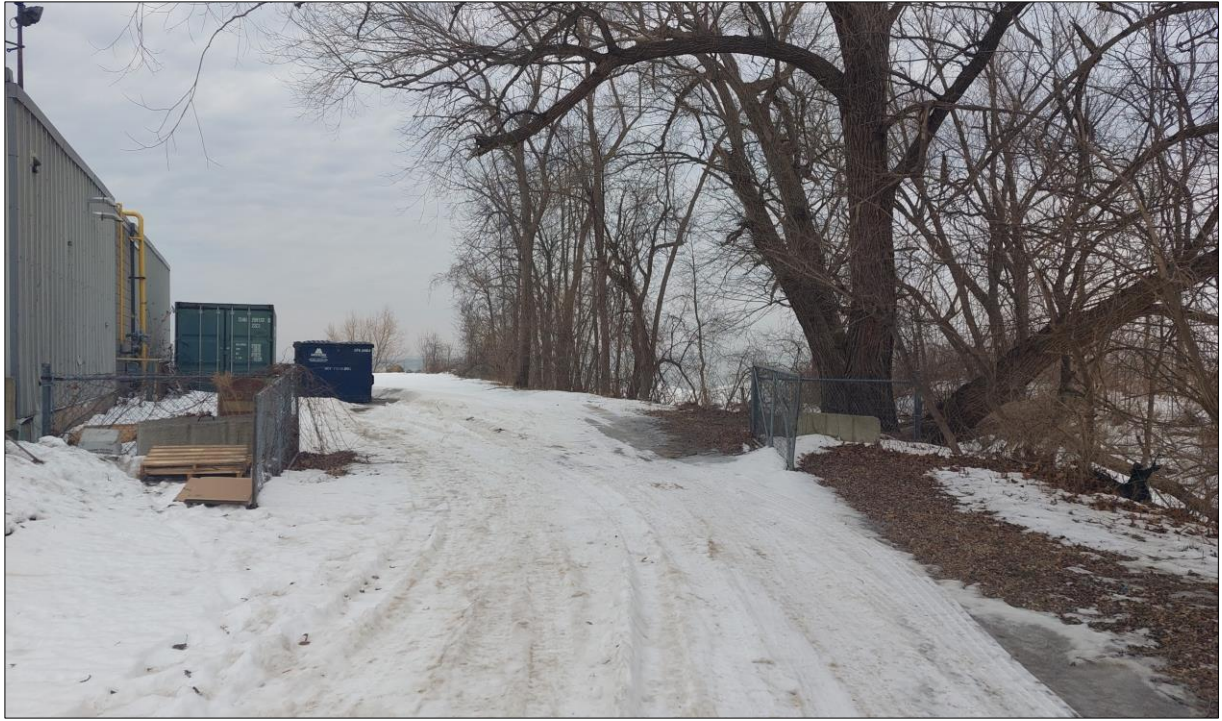
Photograph 1: General view of the northern table land and slope crest, looking north (February 2023).

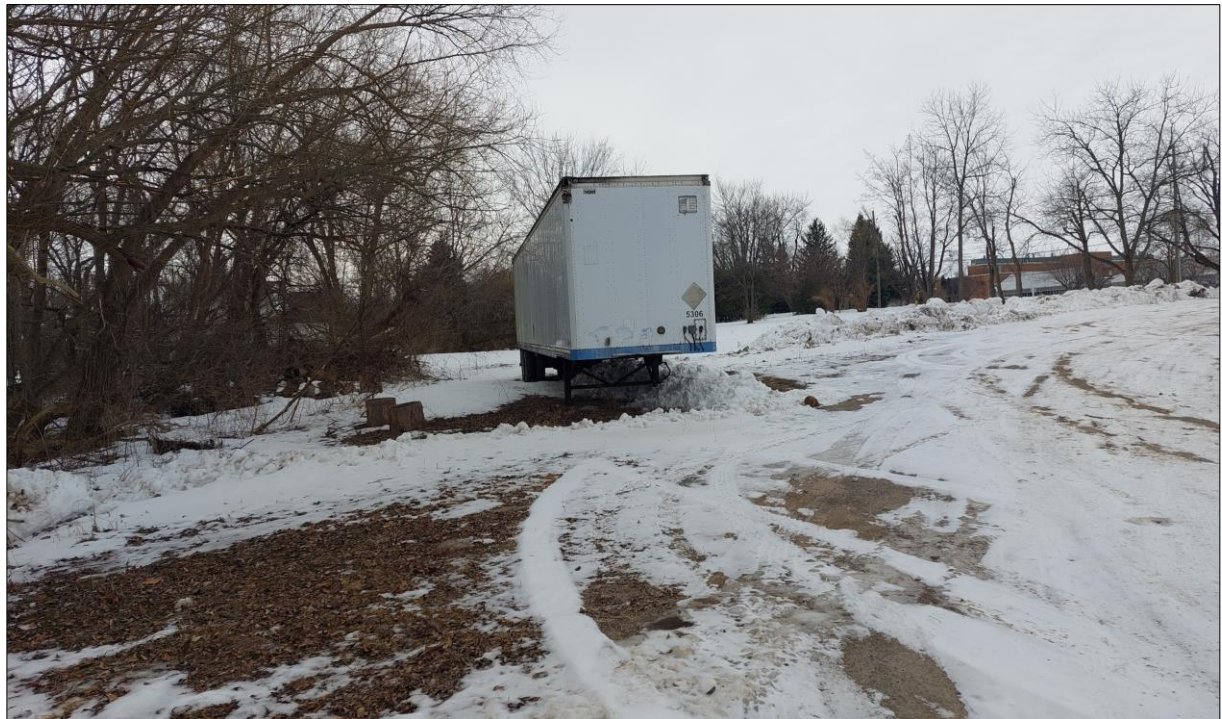
Photograph 2: General view of the southern table land and slope crest, looking south (February 2023).

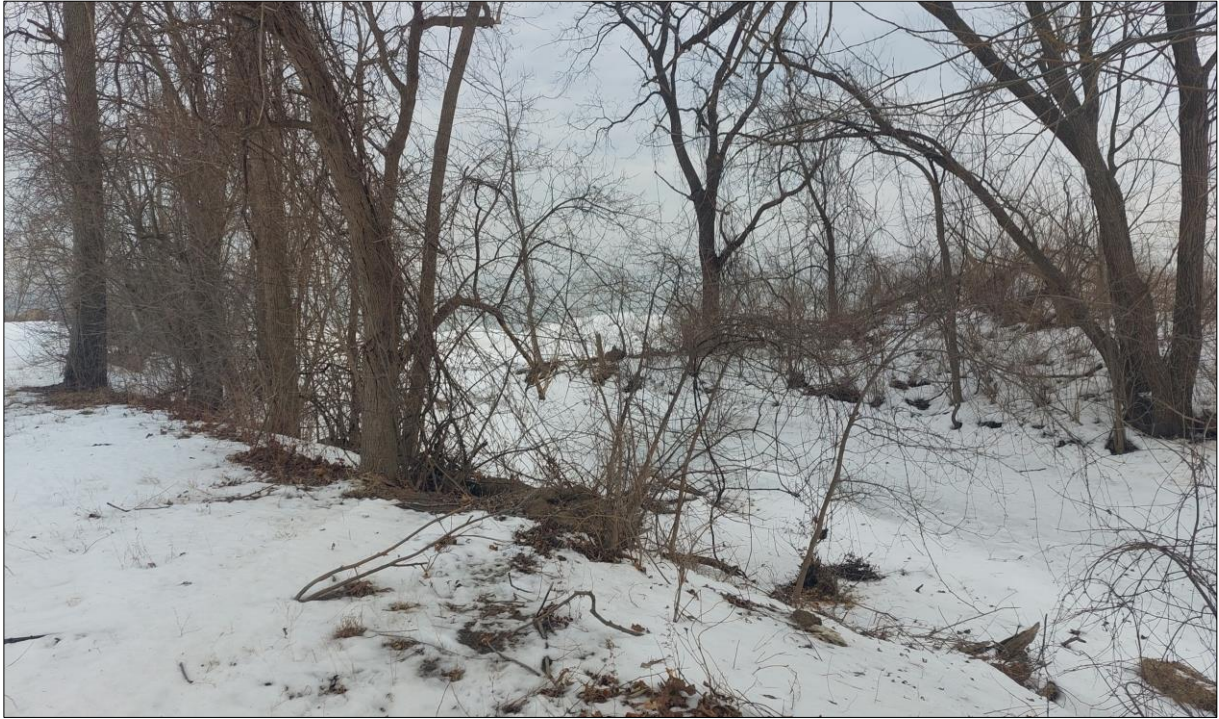
The toe of the slope is inferred as the waters edge of Prudhomme Creek. No evidence of active slope or toe erosion was noted during the site visit, with the slope faces observed being generally consistent in profile and appearance.

Photograph 3: General view of the slope face and creek valley floor, looking northeast (February 2023).

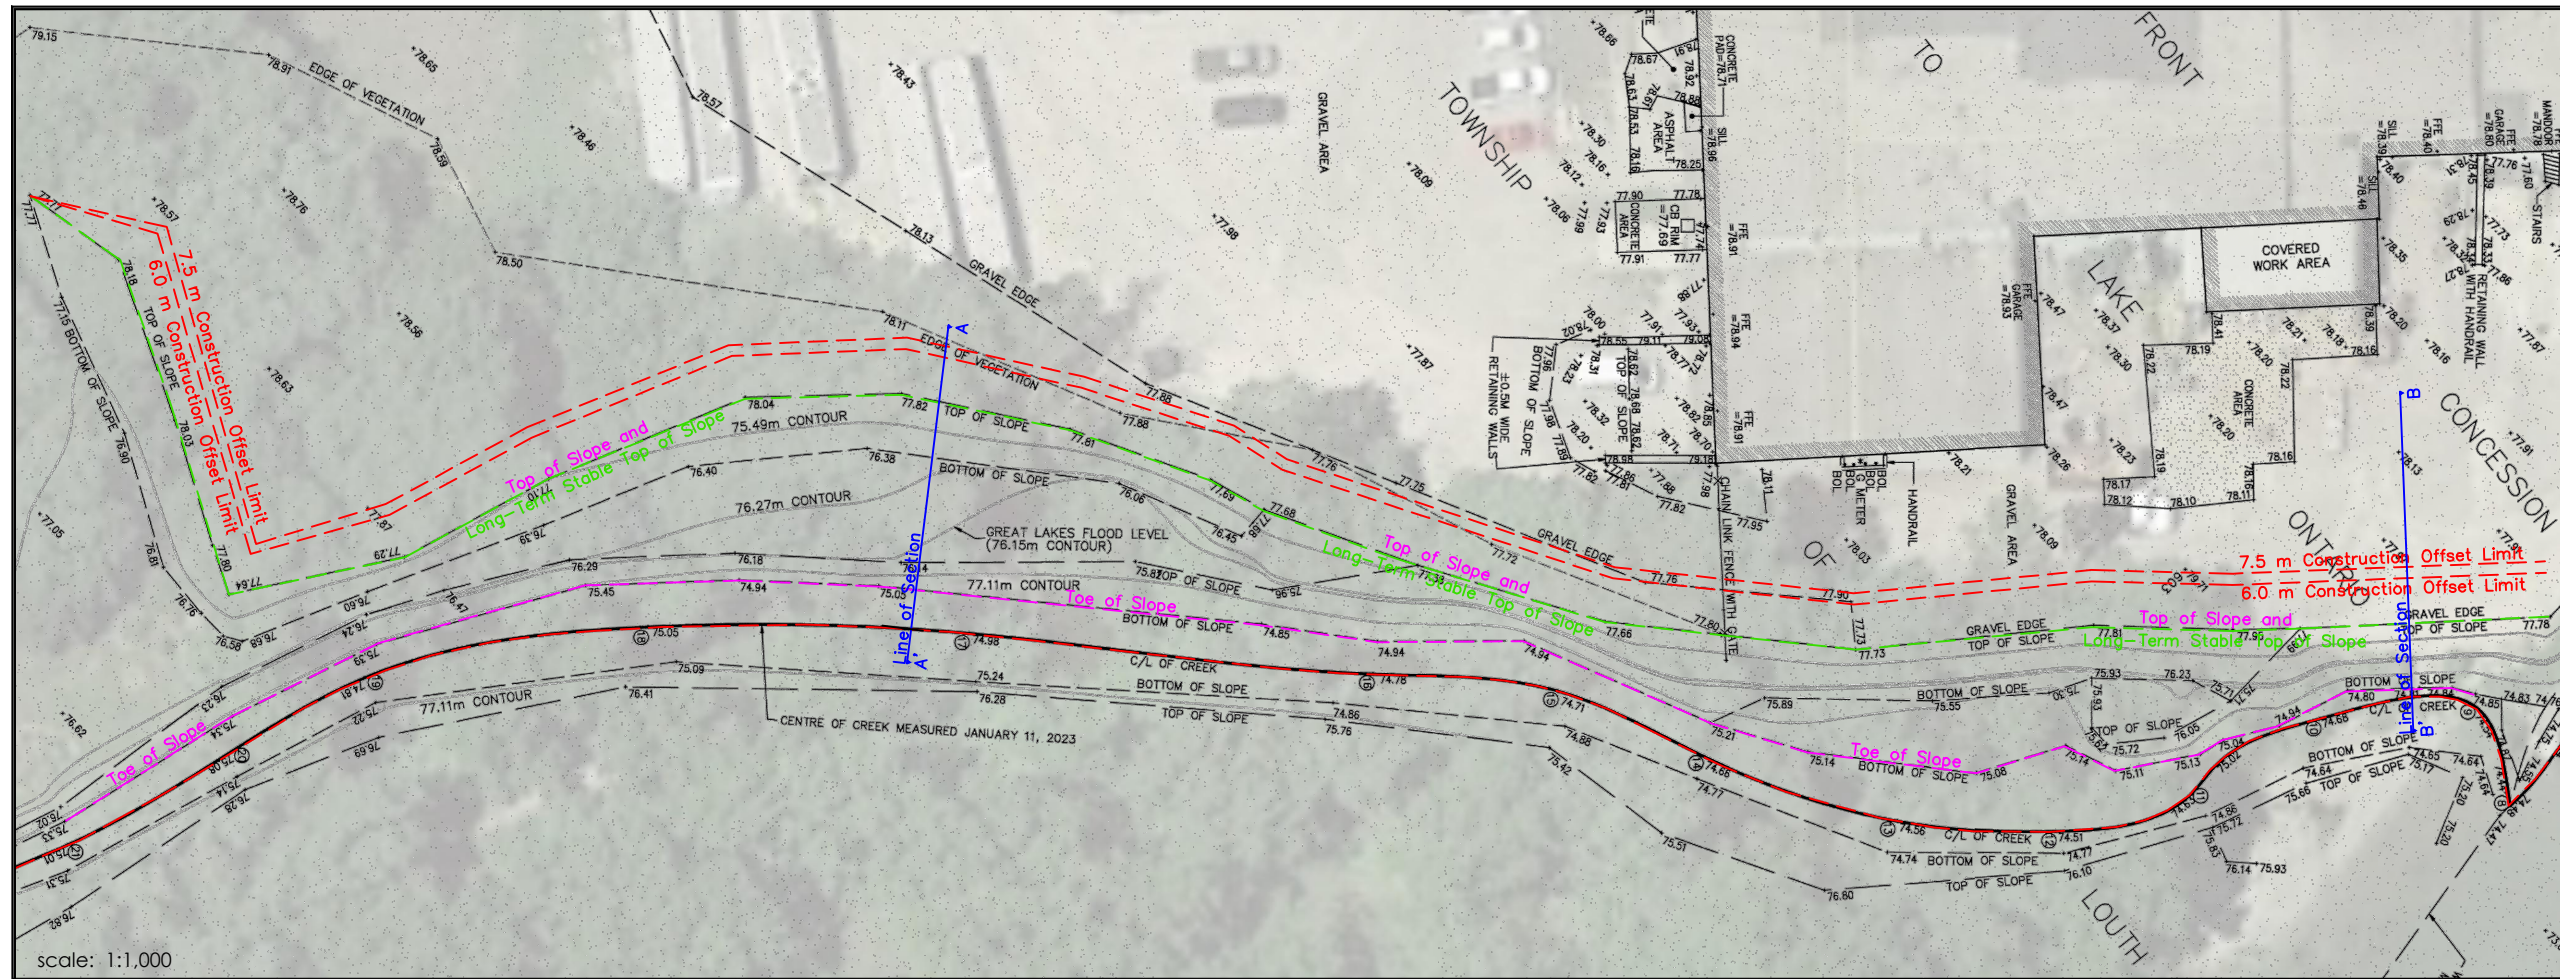
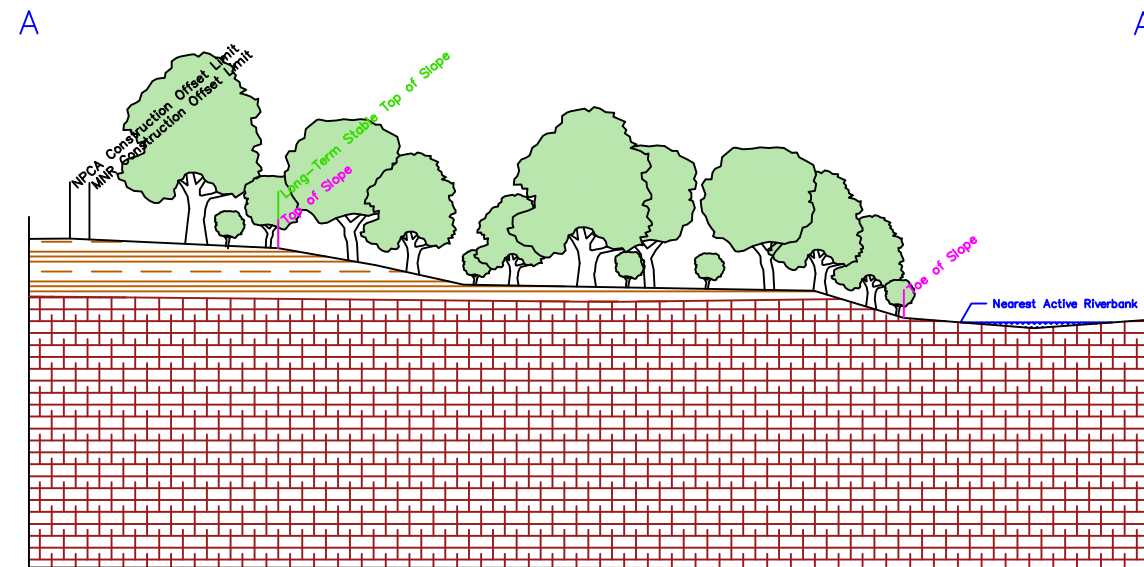
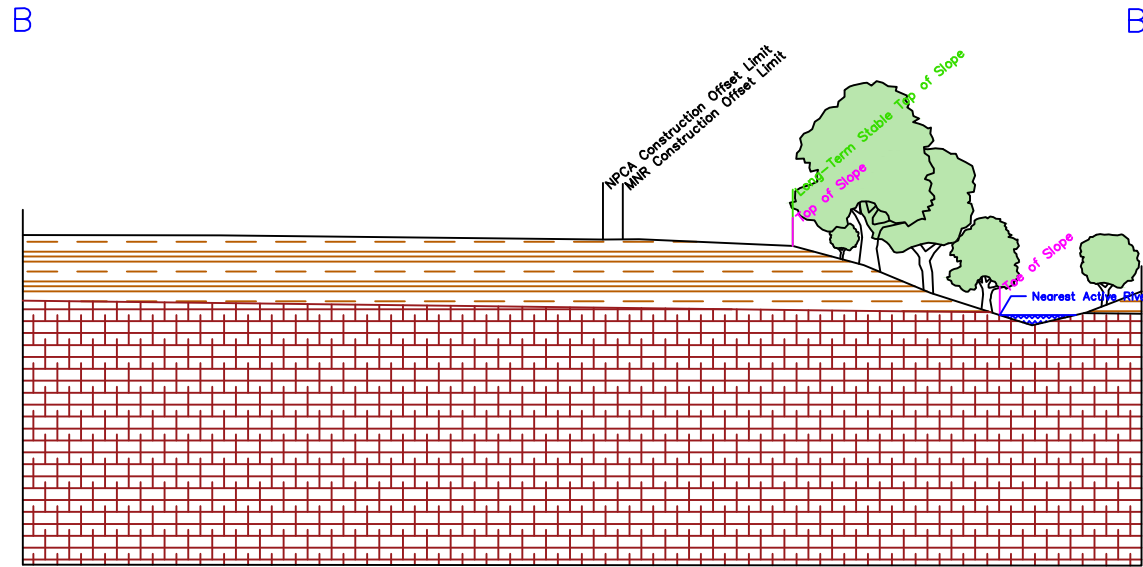
An initial review of the investigated slope was made using measurements on site and topographical information provided to Landtek. General features at the site are shown on Drawing 23016-01 "*Site Features Plan and Section*", attached as Enclosure 4, together with two representative cross-sections of the steepest and shallowest slope areas and their relationship to the current property footprint.

Given the findings of the historical review, the site reconnaissance, slope rating and the measured slope angles being between 16° and 21° (approximately 3H:1V), it is considered that the full modelling of the slope is not necessary. On this basis, the actual Top of Slope presented on Drawing 23016-01 "*Site Features Plan and Section*" is also considered by Landtek to be the LTSTS.

As required by the NPCA, the actual Top of Slope and LTSTS have been defined on Drawing 23016-01 together with the required, calculated NPCA and MNR construction offsets.

$$\begin{aligned} & \text{'Toe Erosion' allowance} + \text{'Stable Slope' allowance} + \text{'Erosion Access' allowance} \\ &= 0.0 \text{ m} + 0.0 \text{ m} + 7.5 \text{ m} \\ &= 7.5 \text{ m (or 6.0 m, if approved) from the actual Top of Slope (i.e., the LTSTS).} \end{aligned}$$

Based on the information provided to Landtek, the proposed development is to be situated approximately 6.0 m away from the actual Top of Slope (i.e., the LTSTS) at its closest and therefore approximately 1.5 m inside of the NPCA's construction offset requirements but in line with MNR construction offset requirements.
